# **INDOOR AIR QUALITY ASSESSMENT**

**Halifax Elementary School  
Silver Lake Regional School District  
464 Plymouth Street  
Halifax, Massachusetts**

Prepared by:  
Massachusetts Department of Public Health  
Bureau of Environmental Health Assessment  
April, 2002

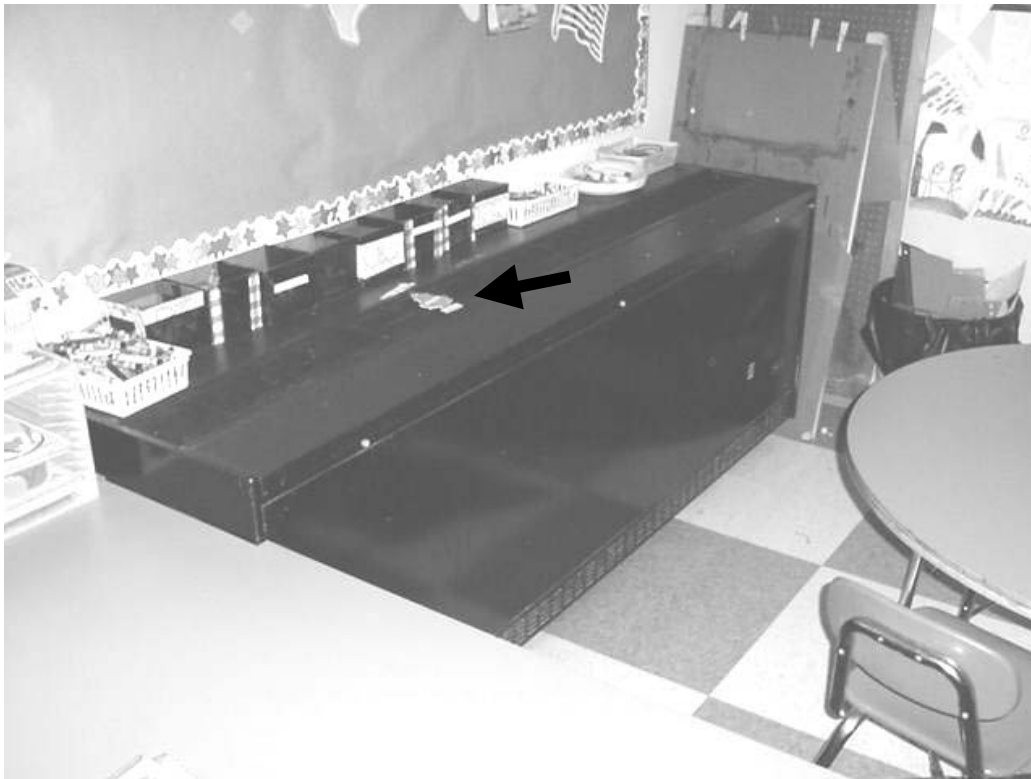
**Picture 1**

Fresh air in classrooms is supplied by a unit ventilator (univent) system (see Picture 1). Univents draw air from outdoors through a fresh air intake located on the exterior walls of the building (see Picture 2) and return air through an air intake located at the base of each unit. The mixture of fresh and return air is drawn through a filter and heating coil, and is then expelled from the univent by motorized fans through fresh air diffusers on the top of each unit ([see Figure 1](#)).

**Classroom Unit Ventilator (Univent)  
Note Christmas Tree Air Freshener on Air Diffuser**

14. Store cleaning products and chemicals properly and keep out of reach of students.
15. Relocate or consider reducing the amount of materials stored in classrooms to allow for more thorough cleaning of classrooms. Clean items regularly with a wet cloth or sponge to prevent excessive dust build-up.

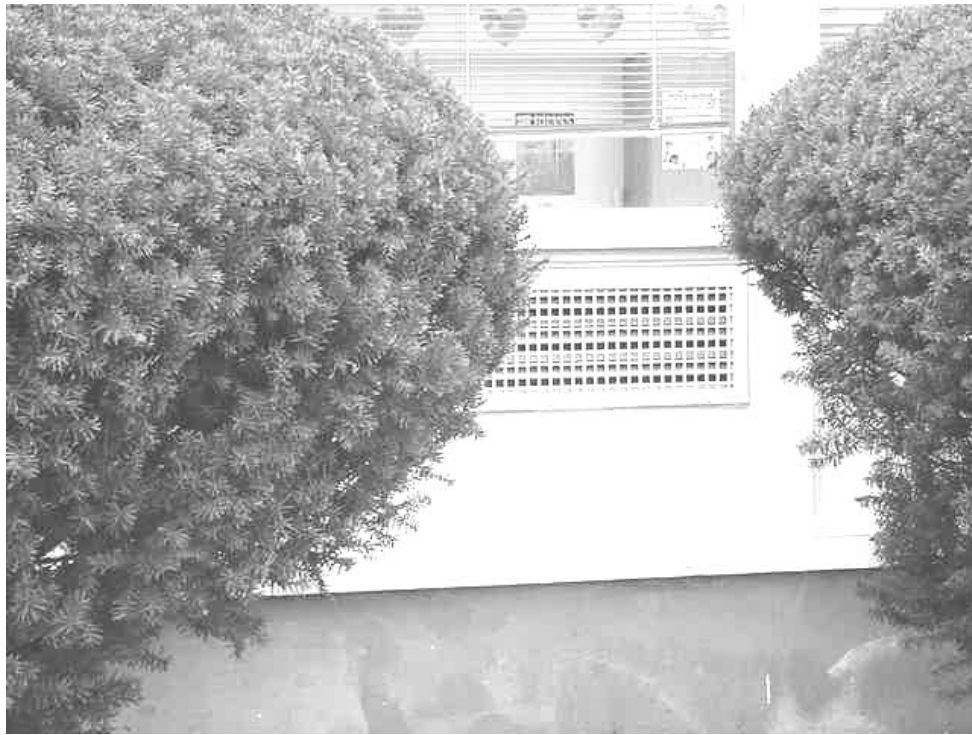
**Picture 2**

Along the perimeter of the building, shrubbery and flowering plants were noted in close proximity to a univent fresh air intake outside of one of the classrooms (see Picture 2). Shrubby and flowering plants can be a source of mold and pollen and should be placed and/or maintained to ensure that fresh air intakes remain clear of obstructions.

**Univent Fresh Air Intake, Note Close Proximity of Shrubbbery**

12. Replace/repair damaged downspouts and install elbows in a manner to direct rainwater away from the building.
13. Inspect plant growth outside perimeter of building periodically; trim plants away from fresh air intakes as needed.

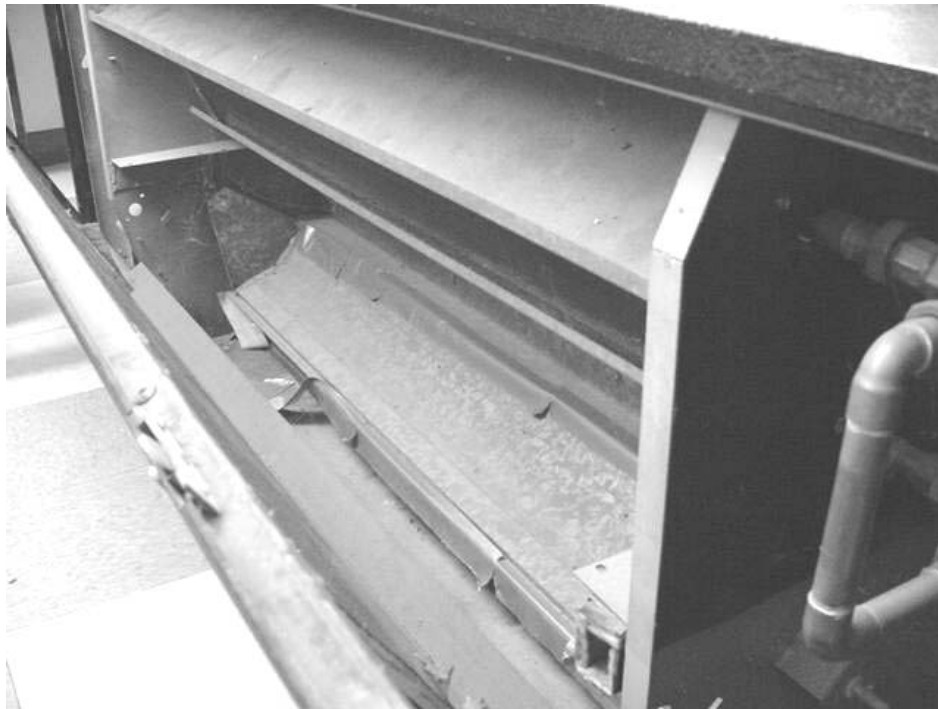
**Picture 3**

Univents were deactivated or inoperable in a number of classrooms surveyed. Several univents were reportedly deactivated at the request of occupants due to excessive heat production, which may indicate a problem with fresh air intakes or thermostatic control. The univent in classroom 125 was reportedly inoperable due to a fuse problem. The univent in classroom 115 lacked essential mechanical components that were removed to repair other units (see Picture 3). To function properly, univents must be activated and allowed to operate during school hours.

**Interior of Univent Missing Fans and Associated Mechanical Components in Classroom 115**

3. Examine each univent for function. Survey classrooms for univent function to ascertain if an adequate air supply exists for each room. Consider consulting a heating, ventilation and air conditioning (HVAC) engineer concerning the calibration of univent fresh air control dampers school-wide.

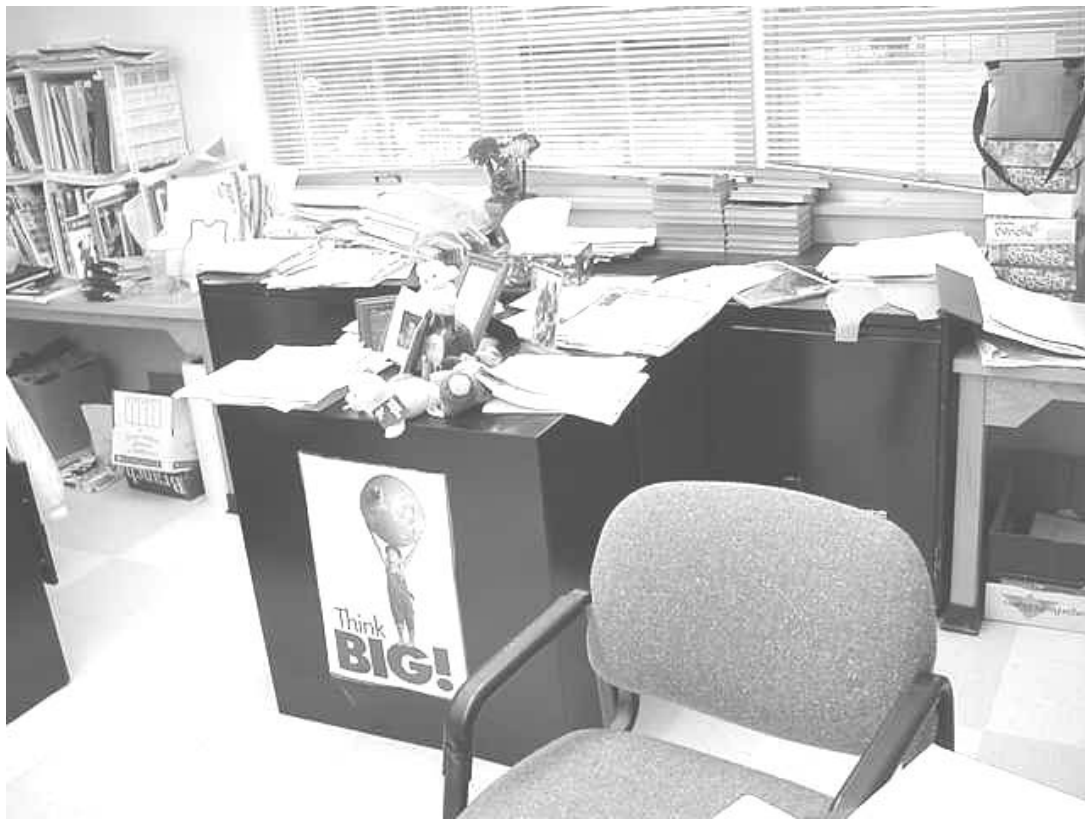
**Picture 4**

Obstructions to airflow, such as books, papers and posters on top of univents, and bookcases, tables and desks in front of univent returns, were seen in a number of classrooms (see Picture 4). The fresh air intake for classroom 204, which is above the library office, was sealed with plywood (see Picture 5). To function as designed, univents and univent returns must remain free of obstructions.

**Univent Air Diffuser (top) Obstructed by Books & Papers;  
Univent Return Vent (along front base of unit) Blocked by File Cabinet**

6. Remove all blockages from univents and exhaust ventilators to ensure adequate airflow. Remove/relocate end coat hook in classrooms nearest to wall-mounted exhaust vent (see Picture 25) to prevent blockage.

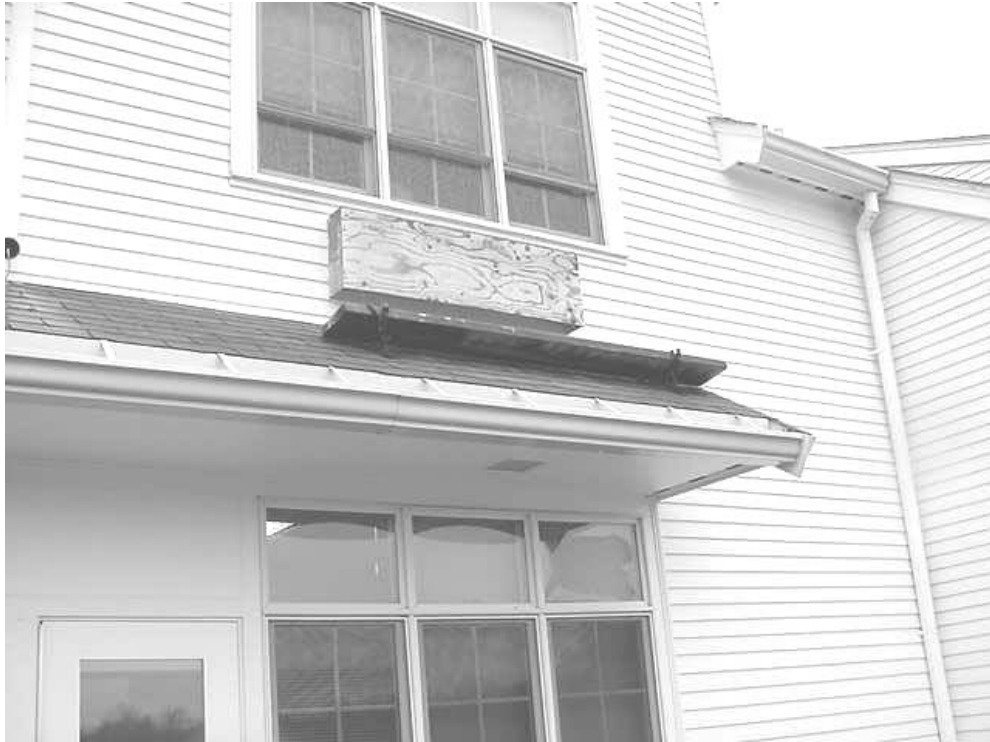
**Picture 5**

**Univent Fresh Air Intake Covered With Plywood**

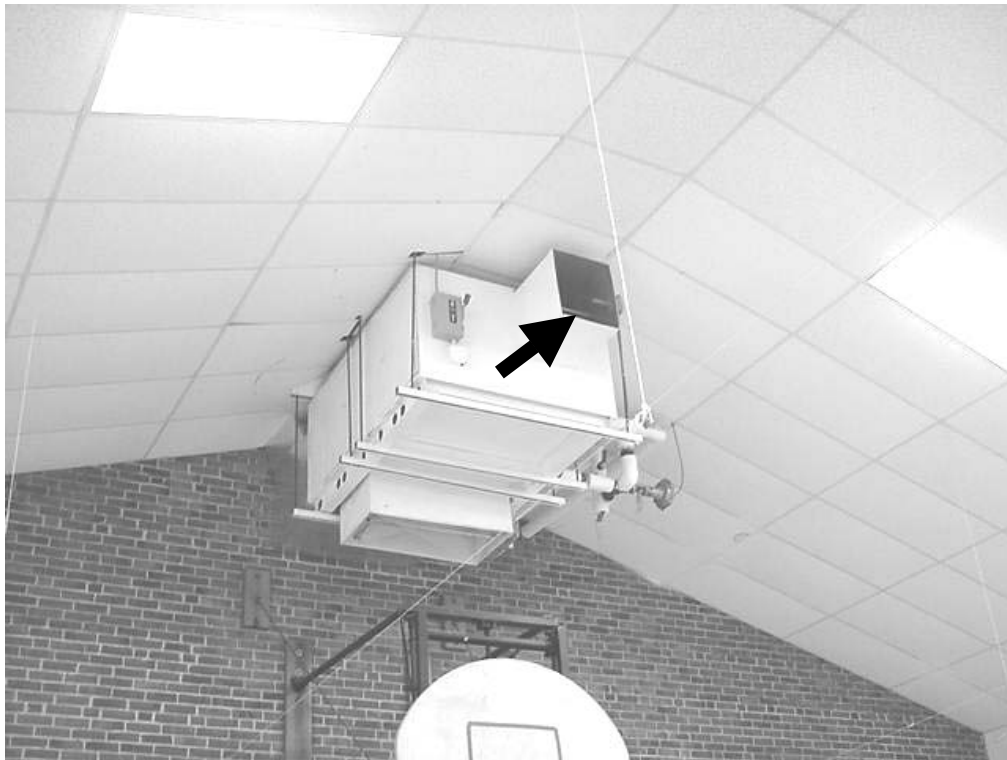
**Picture 6**

Ventilation in the gymnasium, cafeteria and offices is provided by rooftop or ceiling-mounted air handling units (AHUs). The ceiling-mounted AHU in the cafeteria appears to be lacking ductwork, which prevents proper distribution of air throughout the cafeteria (see Picture 6).

**Ceiling-Mounted Air Diffuser in Cafeteria Missing Ductwork**

| Remarks | Carbon Dioxide<br>*ppm | Temp.<br>°F | Relative Humidity<br>% | Occupants<br>in Room | Windows<br>Openable | Ventilation | | Remarks |
|---|---|---|---|---|---|---|---|---|
| Cafeteria | 1048 | 71 | 37 | ~100 | Yes | Yes | Yes | Ceiling Mtd AHU-Not ducted,<br>1 water damaged CT, between lunches |

1. Examine the feasibility of installing a gutter/downspout system to parts of the building that lack them.
2. Consult with architect and or general contractor regarding the integrity of the building envelope, primarily concerning water damage to interior building materials and potential microbial growth due to water penetration issues around dormers and awnings.
3. Consider installing ductwork and air diffusers on cafeteria AHU to ensure proper airflow and distribution.

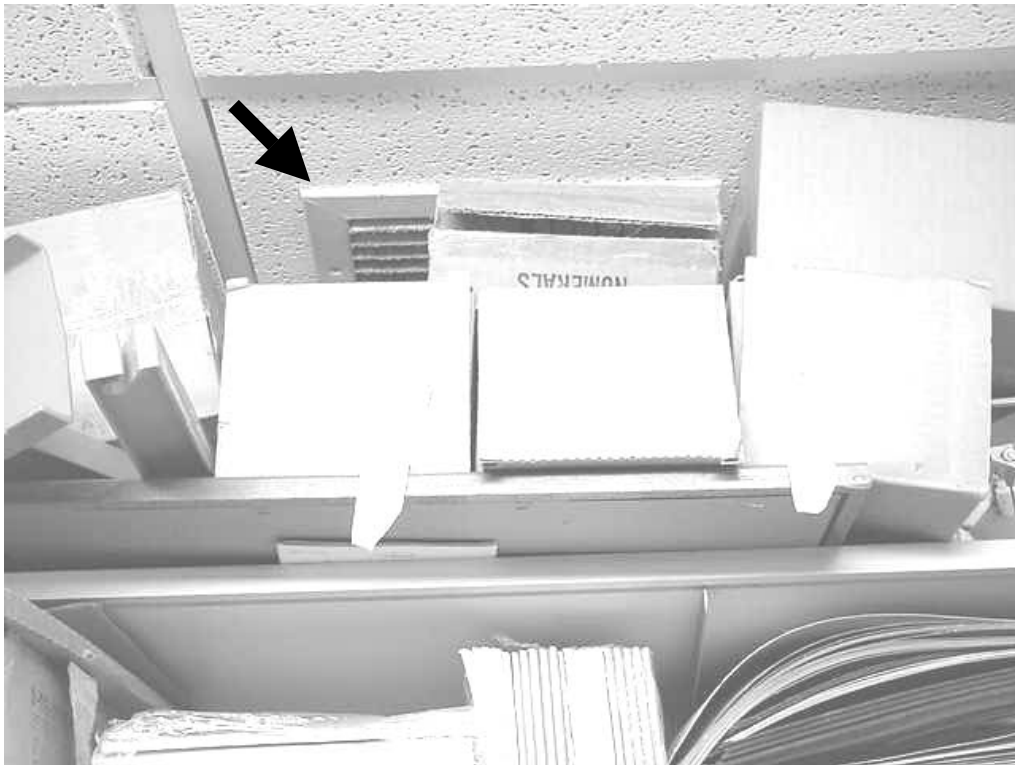
**Picture 7**

**Coat Closet Exhaust Vent Obstructed by Boxes**

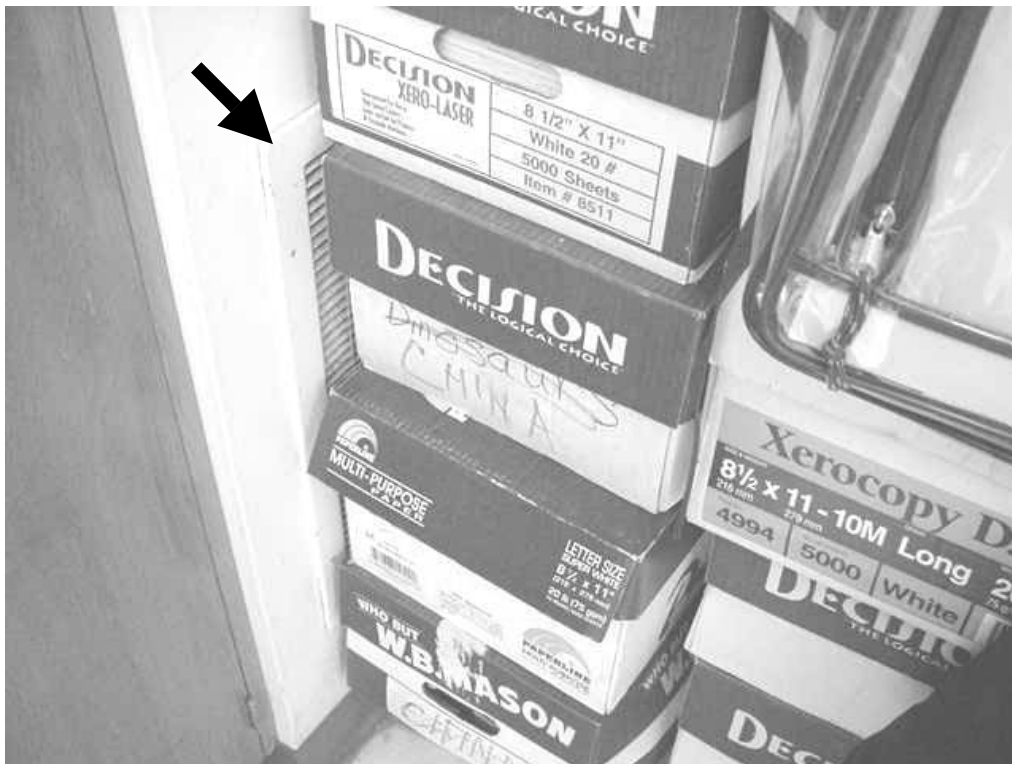
Picture 8

Wall-Mounted Exhaust Vent Obstructed by Boxes

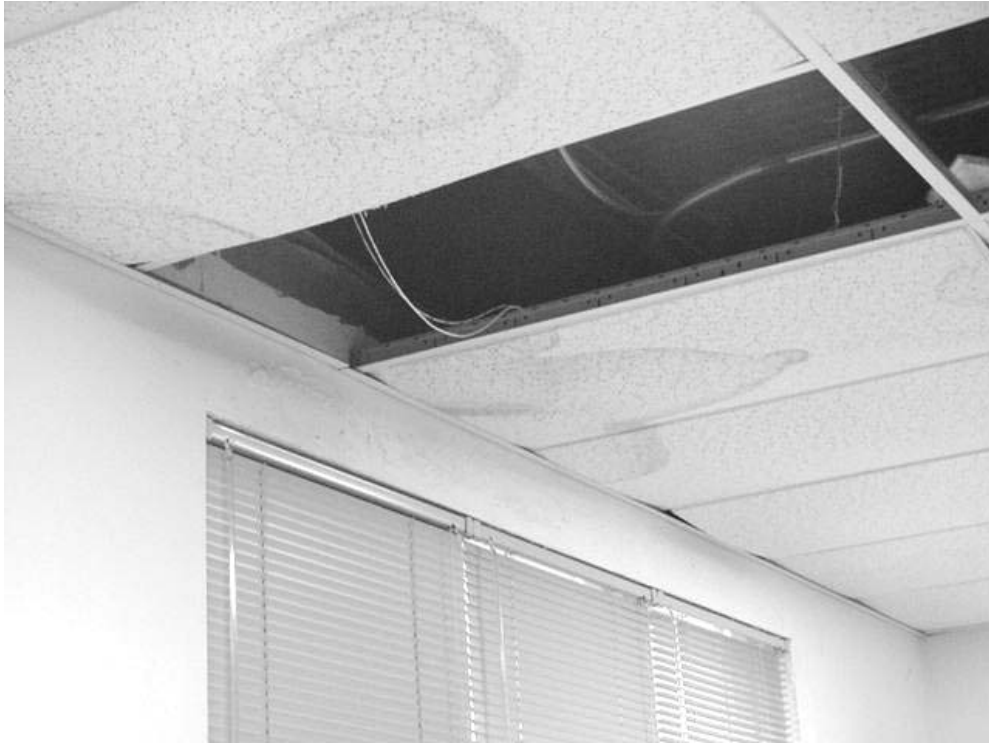
**Picture 9**

The library office, however, appears to be an area of chronic water penetration unrelated to the burst pipe in the library proper, as evidenced by water damaged building materials. Water penetration through the building envelope in this area was indicated by missing/water-damaged ceiling tiles, musty odors and efflorescence (i.e., mineral deposits) on gypsum wallboard (GW) (see Pictures 9 & 10). Efflorescence is a characteristic sign of water damage to building materials such as brick or plaster, but it is not mold growth. As moisture penetrates and works its way through building materials, water-soluble compounds dissolve, creating a solution. As the solution moves to the surface of the material (e.g., GW), water evaporates, leaving behind white, powdery mineral deposits. This condition indicates that water from the exterior has penetrated into the building. Water damaged building materials such as GW and ceiling tiles can serve as a medium to support mold growth, especially if wetted repeatedly. These materials should be replaced after a water leak is discovered.

**Missing/Water-Damaged Ceiling Tiles in Library Office**

11. Replace any remaining water-stained ceiling tiles, GW and pipe insulation. Examine the areas above and around these areas for microbial growth. Inspect wallboard for water-damage and mold/mildew growth, repair/replace as necessary. Disinfect areas of microbial growth with an appropriate antimicrobial as needed.

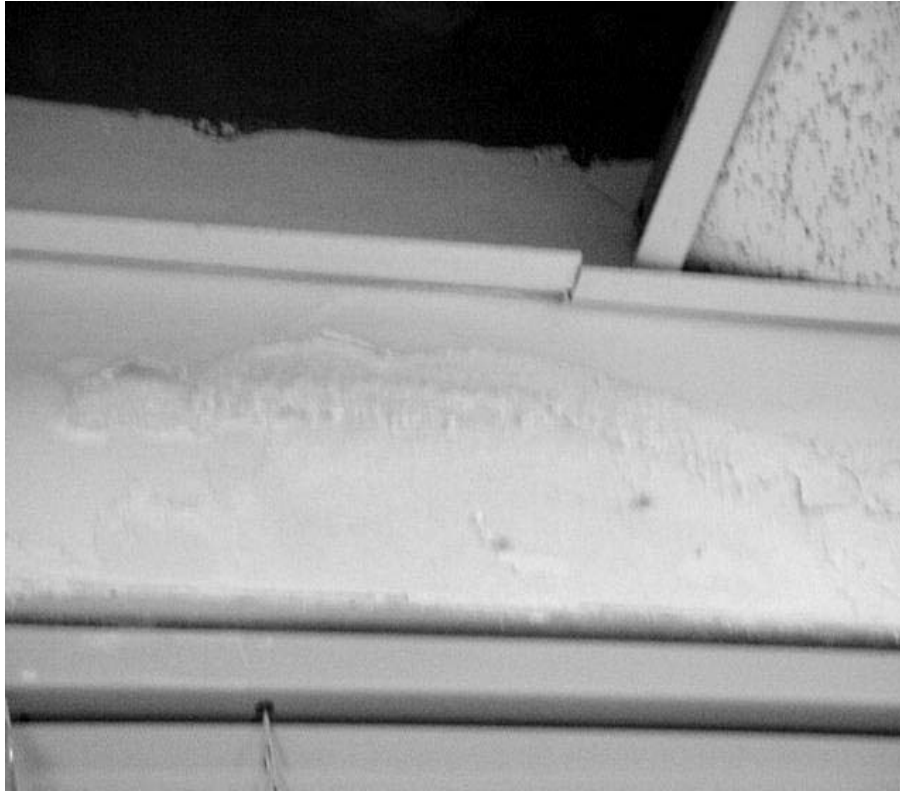
**Picture 10**

**Close-up of Water Damaged Wallboard/Efflorescence in the Library Office**

| Remarks | Carbon Dioxide<br>*ppm | Temp.<br>°F | Relative Humidity<br>% | Occupants<br>in Room | Windows<br>Openable | Ventilation | | Remarks |
|---|---|---|---|---|---|---|---|---|
| Library Office | 566 | 67 | 51 | 0 | | No | No | Water damaged/missing CT, water damage/efflorescence-wall, periodic leaks from building envelope, scaffolding outside, musty odors<br>Moisture content in CT=6.9%<br>Moisture content in wall=6.9%<br>(dry) |

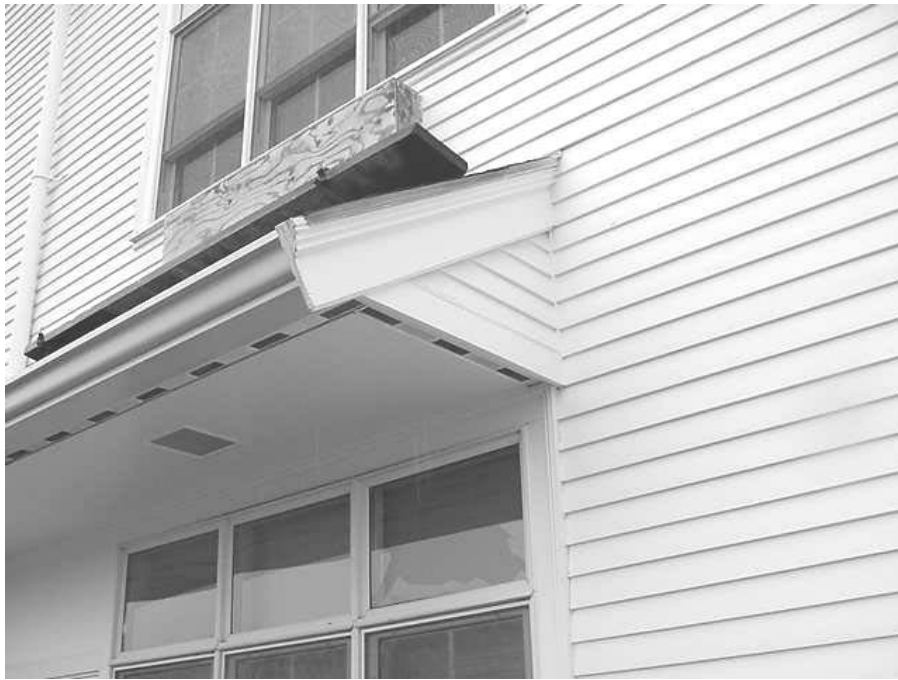
**Picture 11**

The most likely source of water penetration appeared to be junctions around an awning on the exterior wall outside of the library office (see Picture 11). Repair work to the exterior wall in this area was underway as evidenced by scaffolding and the sealing of the univent fresh air intake in this area (as shown in Picture 5). No information regarding the progress or purpose of repairs was available from school personnel.

**Awning Directly Outside of Library Office, Also Note Broken Window**

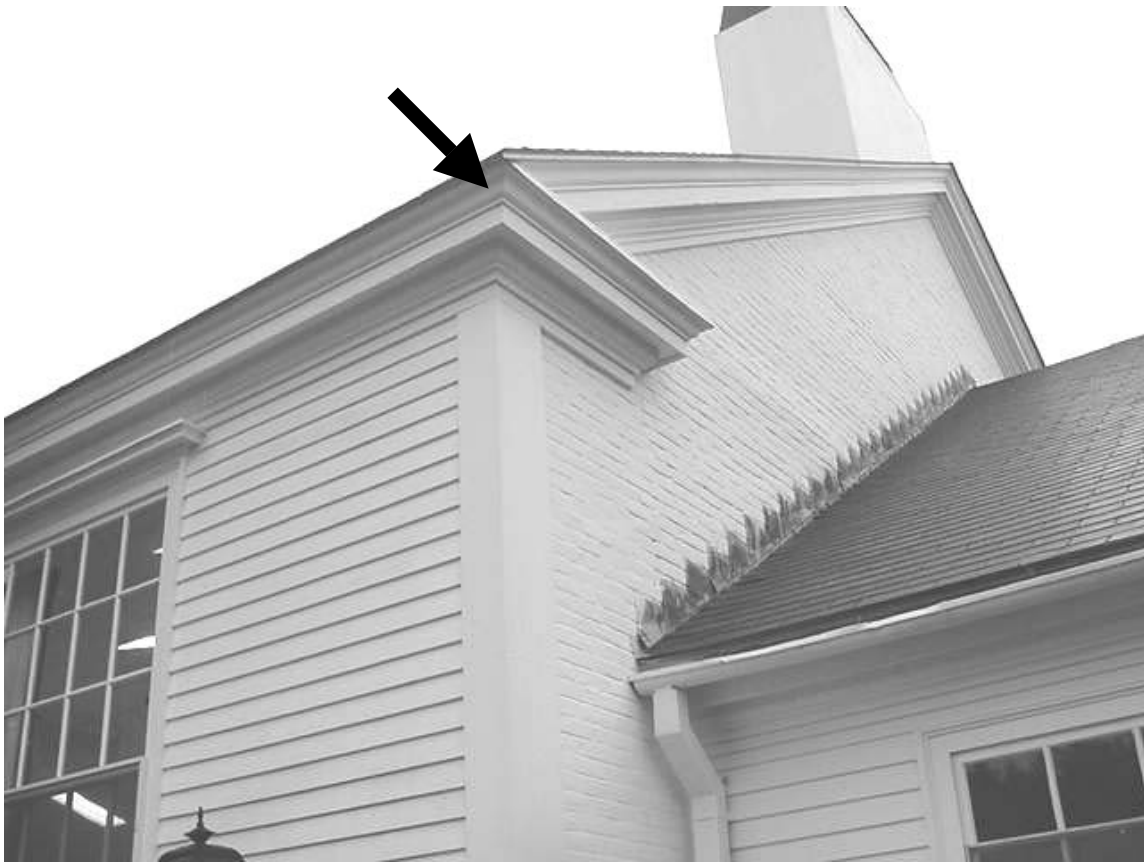
**Picture 12**

Some areas of the peaked roof are not equipped with a gutter/downspout system (see Picture 12). Without such a system, rainwater can run down the side of the building and pool against the foundation. Picture 13 shows a trench with standing water along the perimeter of the building. Several gutters/downspouts were observed to be missing/damaged, which allowed rainwater to pool on the ground at the base of the building or against exterior walls (see Pictures 14 & 15). The freezing and thawing action of water during the winter months can create cracks and fissures in the foundation. Over time, this process can undermine the integrity of the building envelope.

**Portion of Building Not Equipped with Gutters/Downspouts**

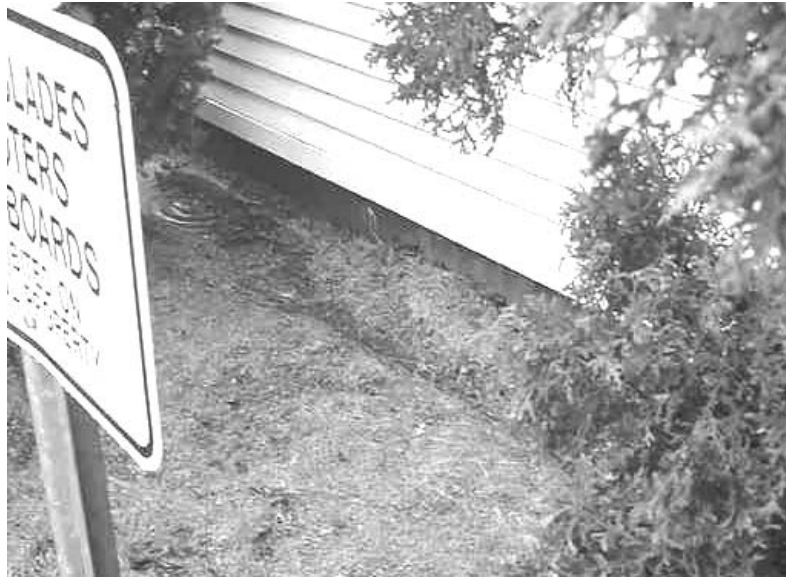
**Picture 13**

**Trench along Building Note Standing Water against Foundation**

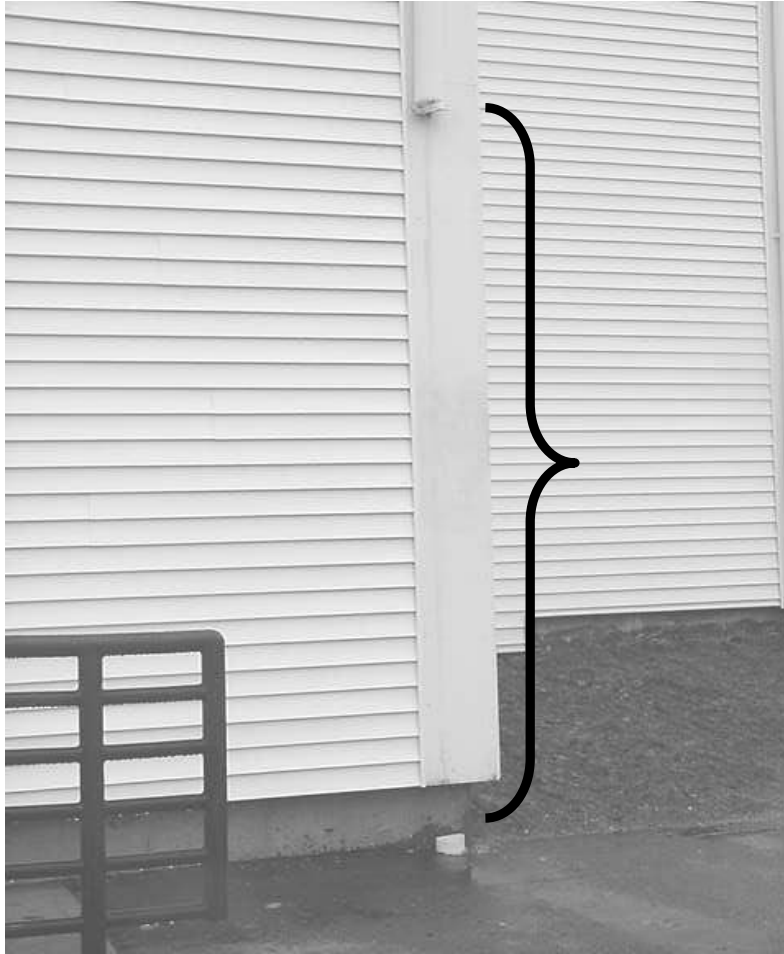
**Picture 14**

**Missing/Damaged Downspout**

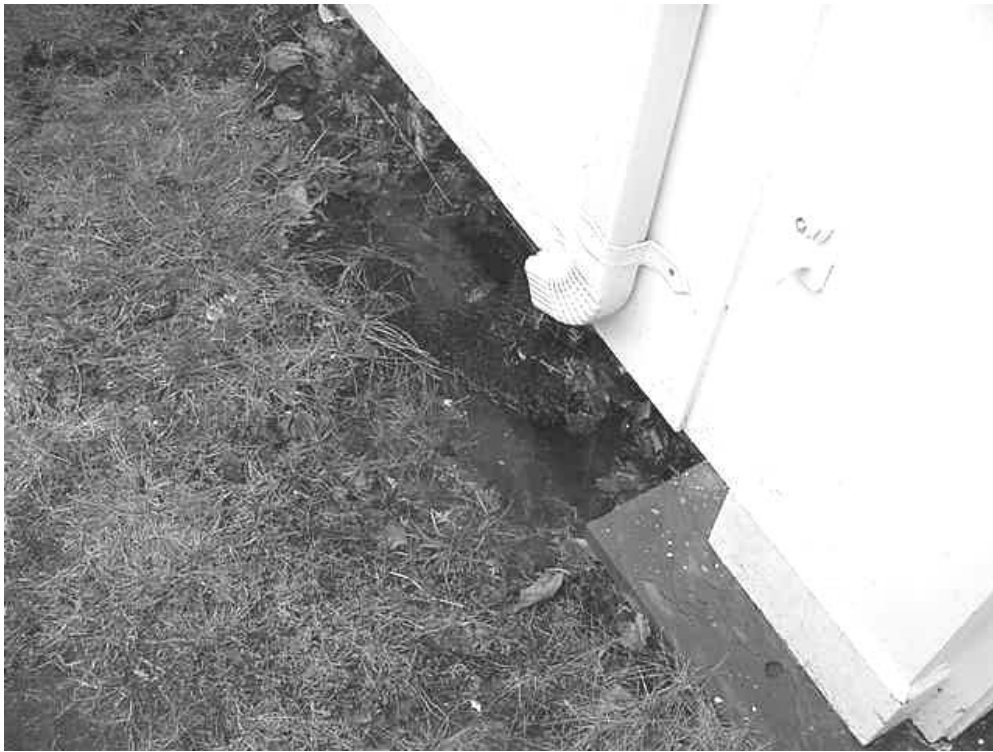
**Picture 15**

**Downspout Directing Water *Toward* Instead of Away From the Building**

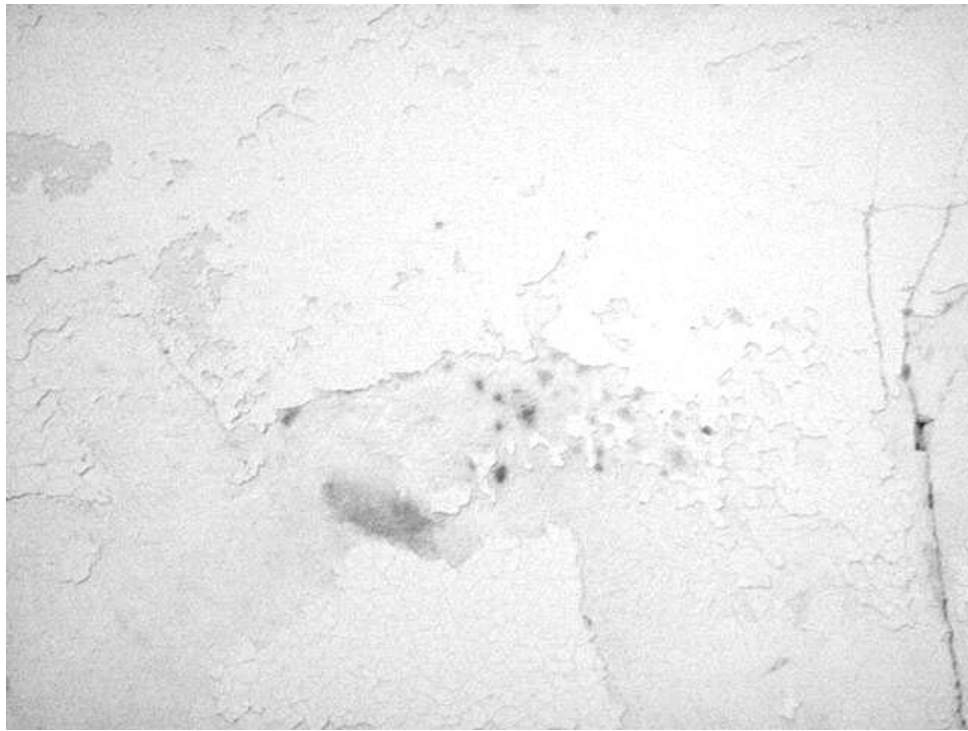
**Picture 16**

complex and requires proper installation of adhesive membranes, roofing paper, taping of insulation around joints and flashing to prevent water penetration and damage to porous building materials. Water staining and efflorescence was noted in classrooms equipped with dormers, which may indicate water leakage through flashing. Picture 16, shows dark staining on GW indicating possible mold growth. No elevated moisture concentration was measured in water damaged GW.

**Water Damage and Peeling Paint in Classroom 203;  
Dark Staining Indicates Possible Mold Growth**

| Remarks | Carbon Dioxide<br>*ppm | Temp.<br>°F | Relative Humidity<br>% | Occupants<br>in Room | Windows<br>Openable | Ventilation | | Remarks |
|---|---|---|---|---|---|---|---|--|
| Room 203 | 1077 | 75 | 32 | 18 | Yes | Yes | Yes | peeling paint/water damage-wall & along base boards, water damaged wall plaster-dormer, possible mold growth/staining, door open |

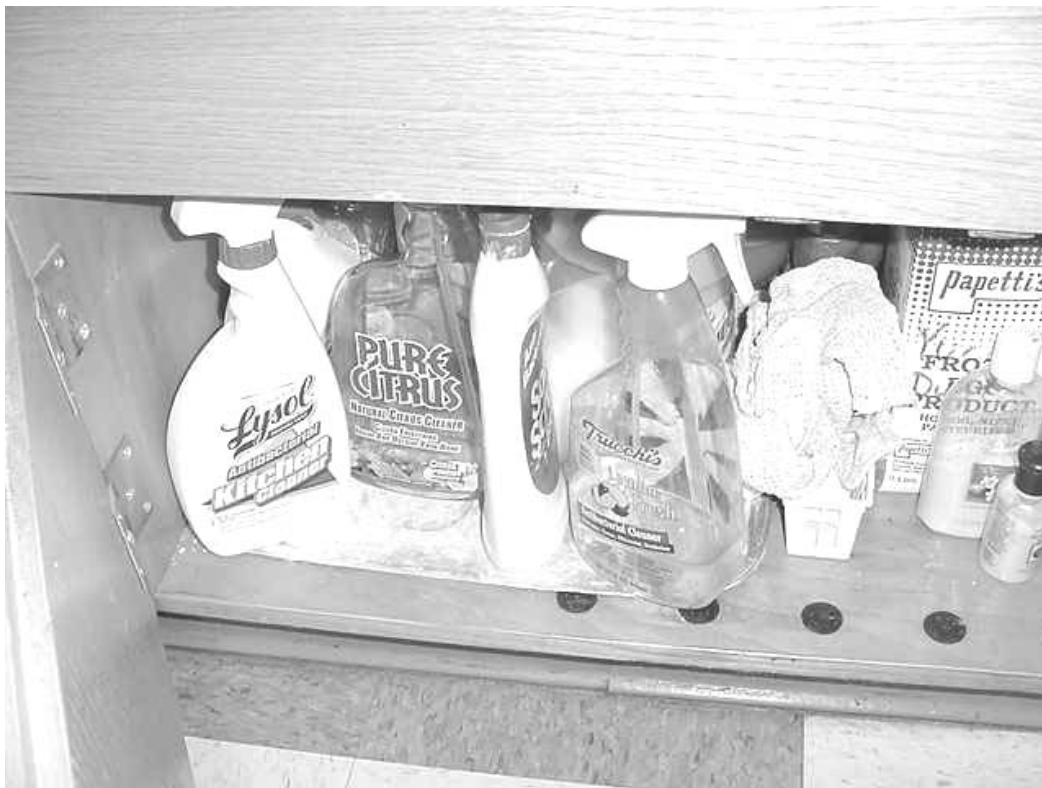
**Picture 17**

Several other conditions were noted during the assessment, which can affect indoor air quality. Cleaning products and other unlabeled materials were found on counter-tops and beneath sinks in a number of classrooms (see Picture 17). Products should be kept in their original containers or be clearly labeled as to their contents, for identification purposes in the event of an emergency. The scent of deodorizer was detected upon entry into classrooms 103 and 123. The sources of the odors were identified as a plug-in air freshener in classroom 123 and a Christmas tree-type air freshener on top of the univent air diffuser in classroom 103. Also noted were at least four or five of the same type of air fresheners inside the fan housing of the unit (see Picture 18). Air fresheners and cleaning products contain chemicals that can be irritating

**Cleaning Products and Other Materials in Unlocked Cabinet below Classroom Sink**

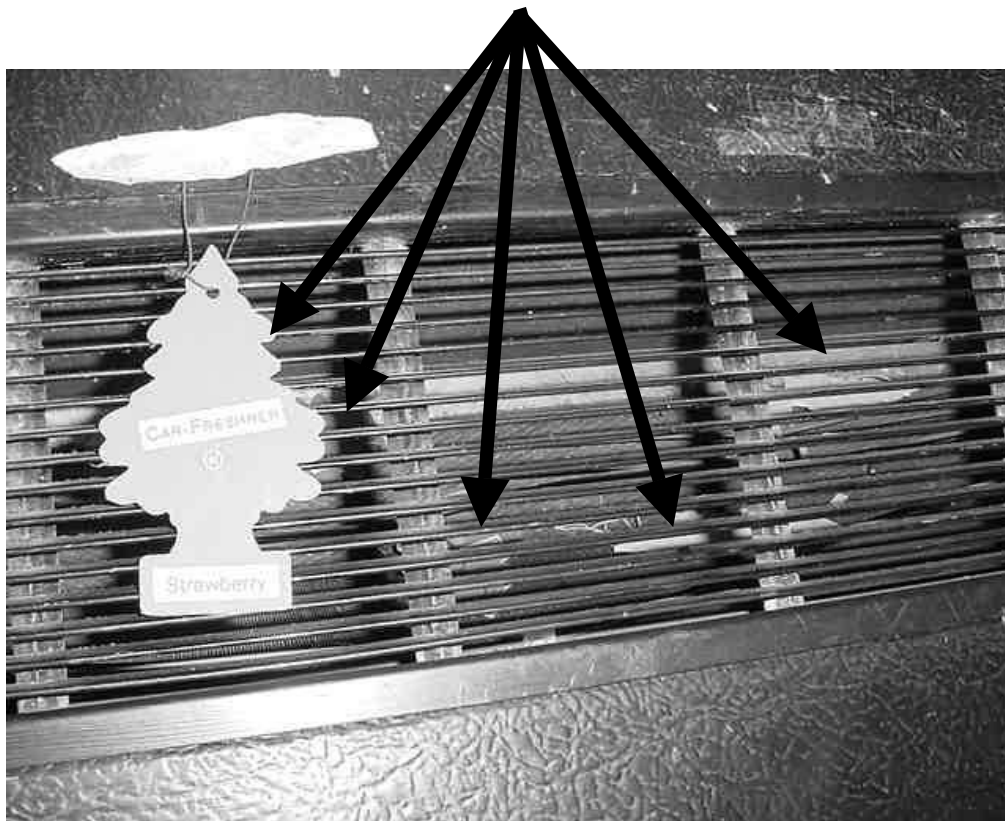
**Picture 18**

**Air Fresheners on and Inside Univent Air Diffuser**

16. Ensure exhaust ventilation is functioning in areas that contain lamination machines and photocopiers.
17. Refrain from using strong scented materials (e.g., air fresheners) in classrooms.

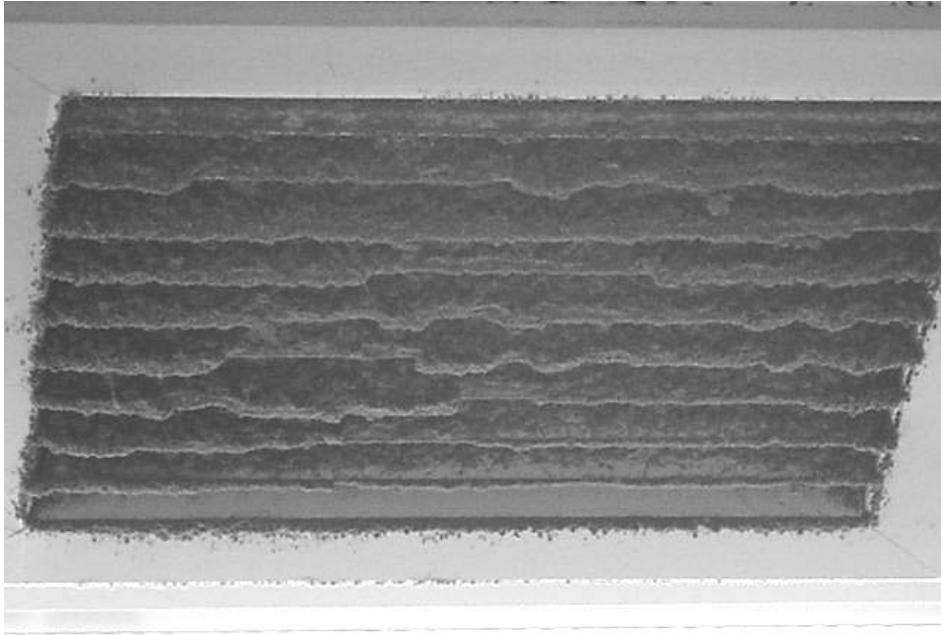
**Picture 19**

**Accumulated Dust/Debris on Exhaust Vent**

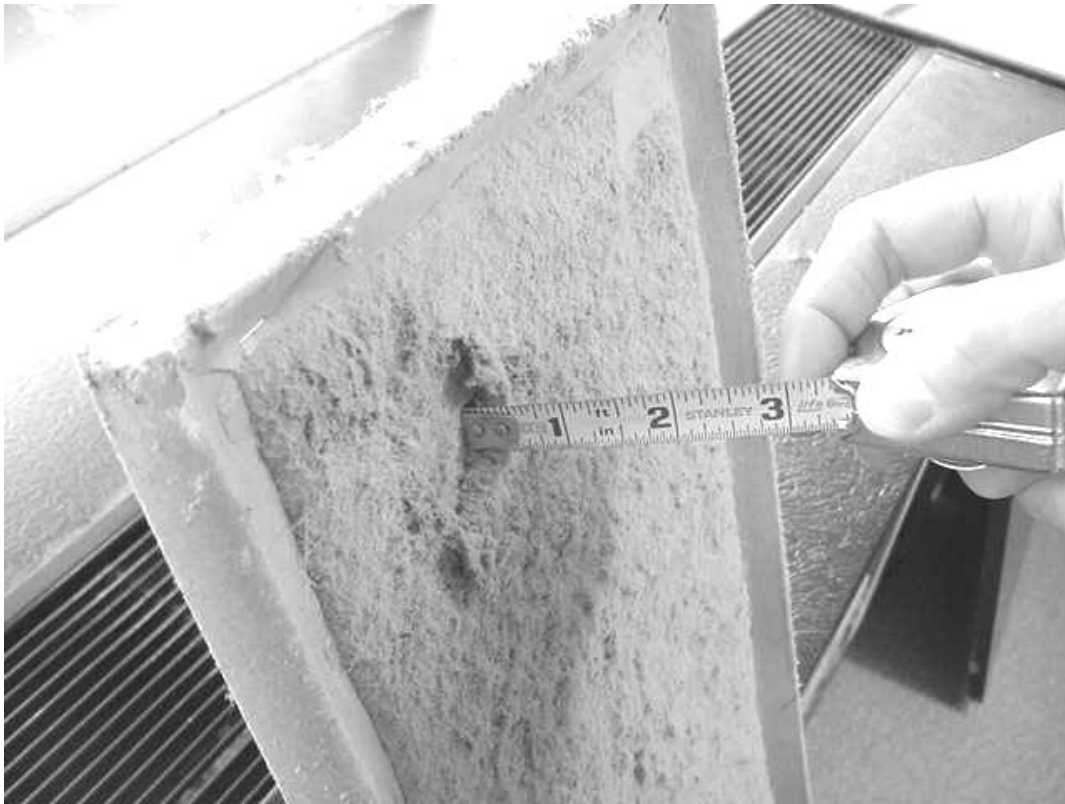
**Picture 20**

BEHA staff inspected filters for classroom univents and found the filter in the music room coated with up to a half inch of dirt/dust and accumulated material (see Picture 20). A debris-saturated filter can obstruct airflow and may serve as a reservoir of particulates that can be re-aerosolized and distributed to occupied areas via the ventilation system.

**Univent Filter in Music Room Coated with Dirt & Debris**

1. Work with the Silver Lake Regional School District to develop a preventative maintenance program for all HVAC equipment.
2. Change filters for air-handling equipment as per the manufacturer's instructions or more frequently if needed. Clean out interiors of univents and AHUs during each filter change.

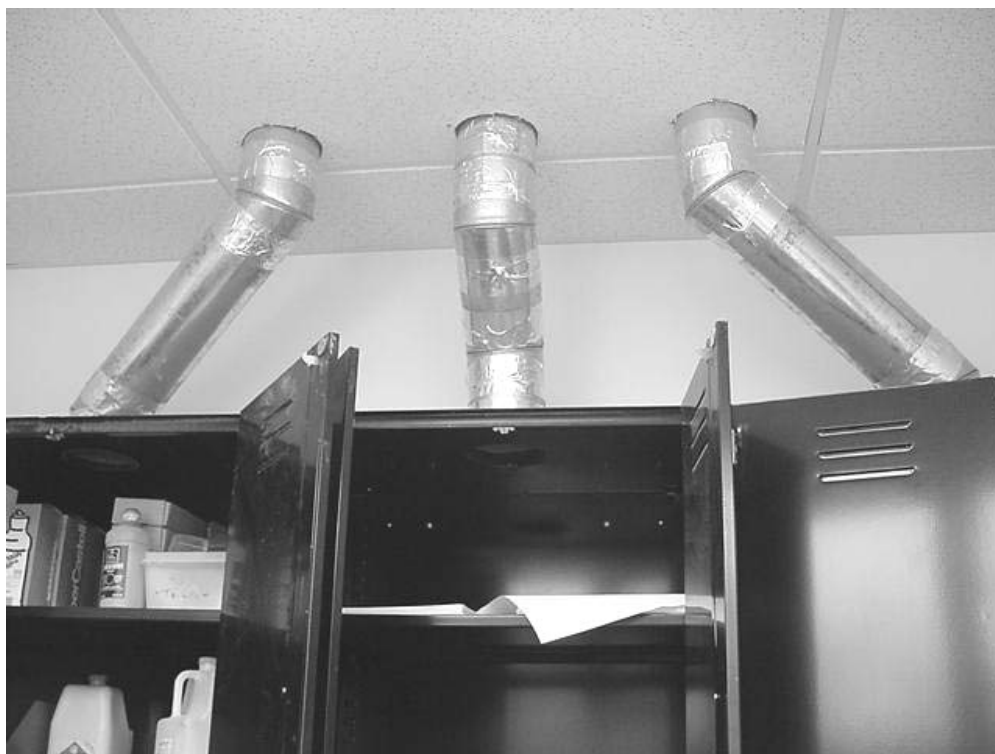
**Picture 21**

A flammable storage cabinet was found in the art storage room (129). This cabinet was vented to the outside by ductwork (see Picture 21). The NFPA does not require venting in flammable storage cabinets. However, it is recommended that if a flammables storage cabinet is connected to a vent system, the vent system should not be constructed in a manner to provide an oxygen source to the interior of the cabinet and it must be vented directly outdoors and not in a manner which might compromise the specific performance of the cabinet (NFPA, 1996). The mechanical exhaust fan was not functioning during the assessment, allowing backdrafting into the cabinet. BEHA staff also noted chemical odors upon opening the cabinet, likely emanating from spilt materials and/or improperly secured containers (see Picture 22). Chemicals used in art (e.g., spray paints, fixatives) often contain VOCs, which can result in odors, irritant symptoms in the eyes, nose and throat, and are a potential fire hazard.

**Ducted Flammables Cabinet in Art Storeroom (129)**

18. Clean chalkboards and trays regularly to prevent the build-up of excessive chalk dust.
19. Replace missing/damaged ceiling tiles.
20. Either restore local mechanical exhaust ventilation to flammable storage cabinet in art storage room or consider removing ductwork and sealing hole to render cabinet airtight.

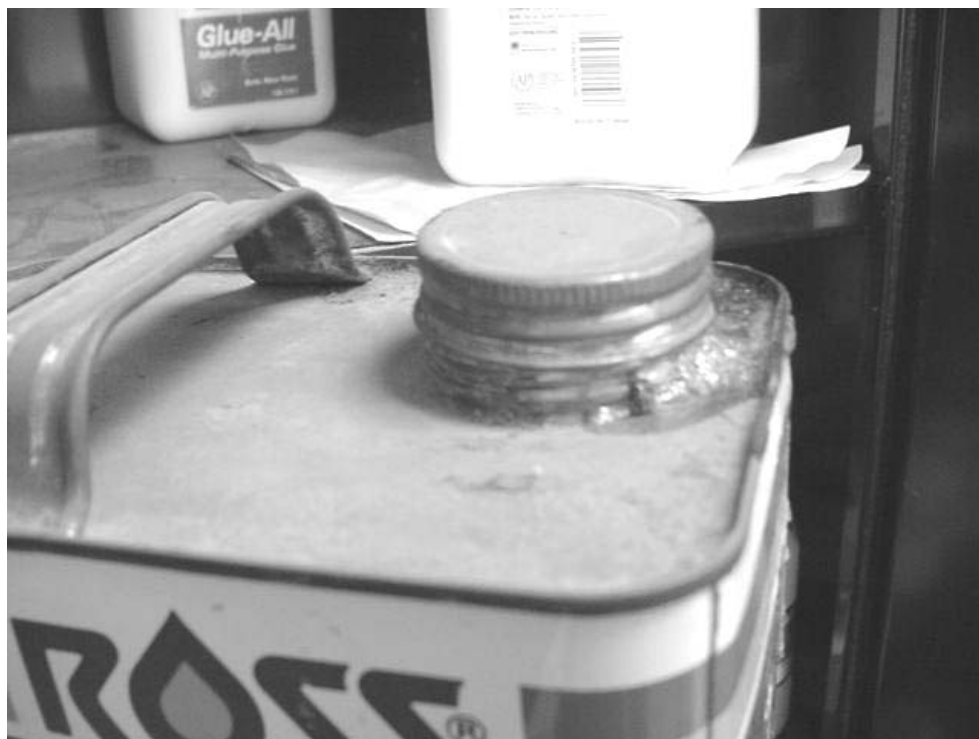
**Picture 22**

**Close-up of Container of Rubber Cement, Note Cap not Fully Secured and Material Leaked Out**

21. Have a chemical inventory done in all storage areas and classrooms. Discard hazardous materials or empty containers of hazardous materials in a manner consistent with environmental statutes and regulations. Follow proper procedures for storing and securing hazardous materials. Obtain Material Safety Data Sheets (MSDS') for chemicals from manufacturers or suppliers.
22. Remove bees/hornet's nest and bird's nest from exterior of building in a manner as to not introduce insects, pesticides or bird wastes into the building. Consider installing screens around vent in Picture 25 to prevent the reoccupation of birds.

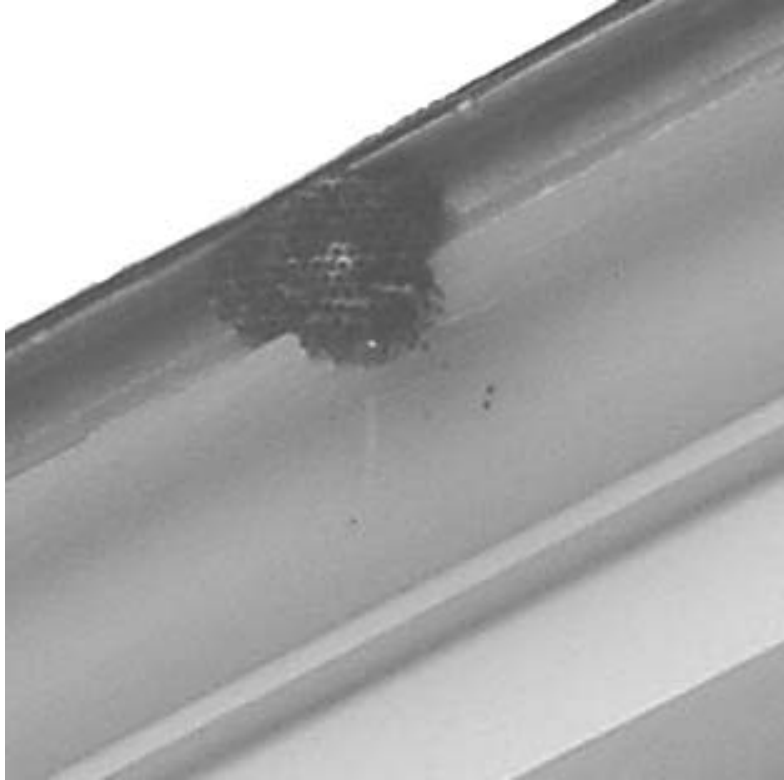
**Picture 23**

A bee/hornet's nest was observed along the perimeter of the building (see Picture 23). Evidence of bird roosting was also noted outside the building in the form of nesting materials and accumulated bird wastes in a vent along the front of the building (see Picture 24). Due to the height and limited interior access to this vent, BEHA staff were not able to determine if the vent was sealed. If open, this vent can provide a means of

**Bee/Hornets Nest Along Perimeter of Building**

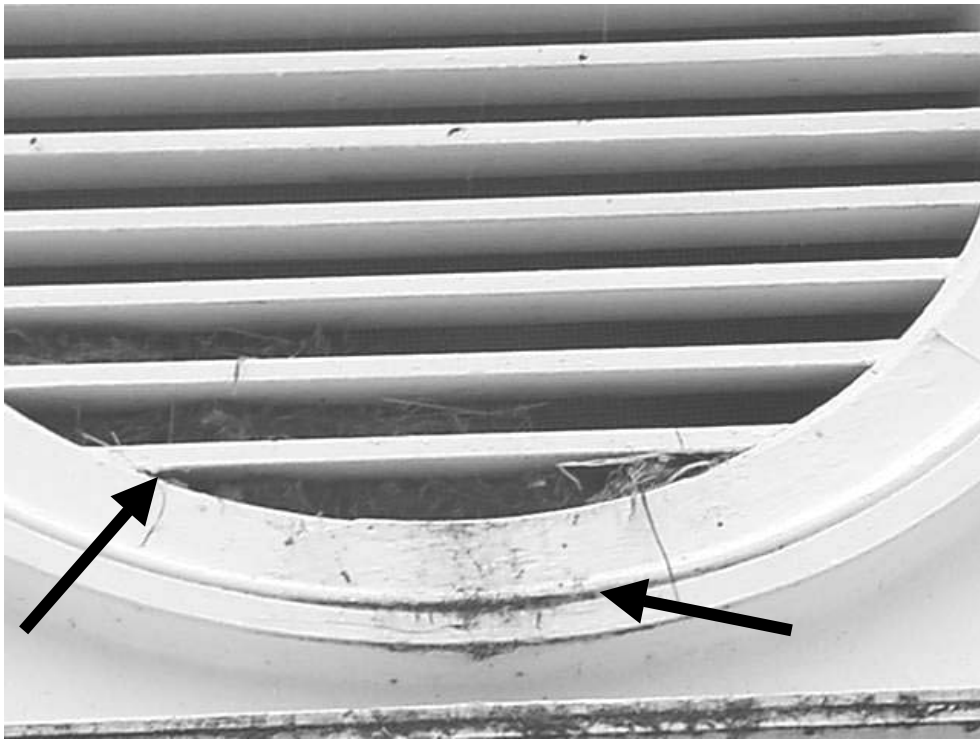
**Picture 24**

egress for birds and associated wastes/odors into the building. Birds can be a source of disease, and bird wastes and feathers can contain mold and mildew, which can be irritating to the respiratory system.

**Nesting Materials and Bird Wastes**

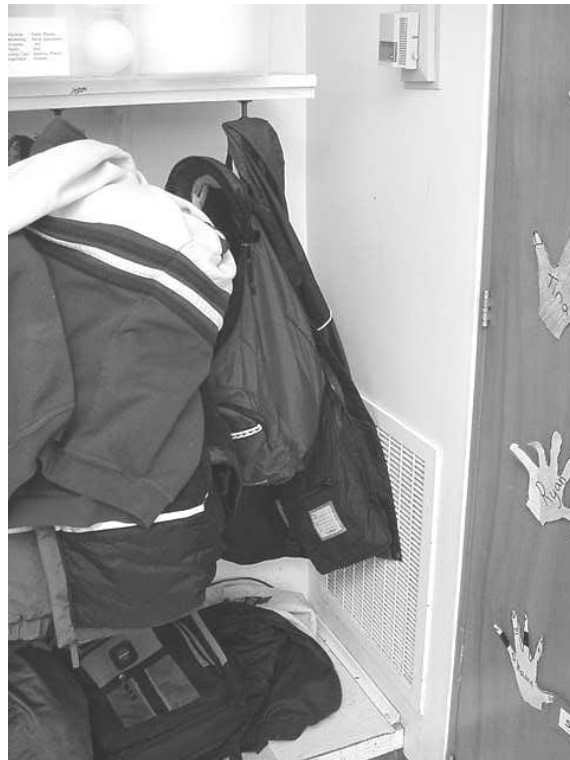
**Picture 25**

**Coats Blocking Airflow to Exhaust Vent**
